Warranty is a growing concern for all partners in the distribution of A/C Components. Because of the growing number of warranty questions, please study the following pictures to familiarize yourself with unsuitable warranty claims.

## Clutches

## T/CCI / Tecumseh Compressors

## Sanden / Seltec Compressors

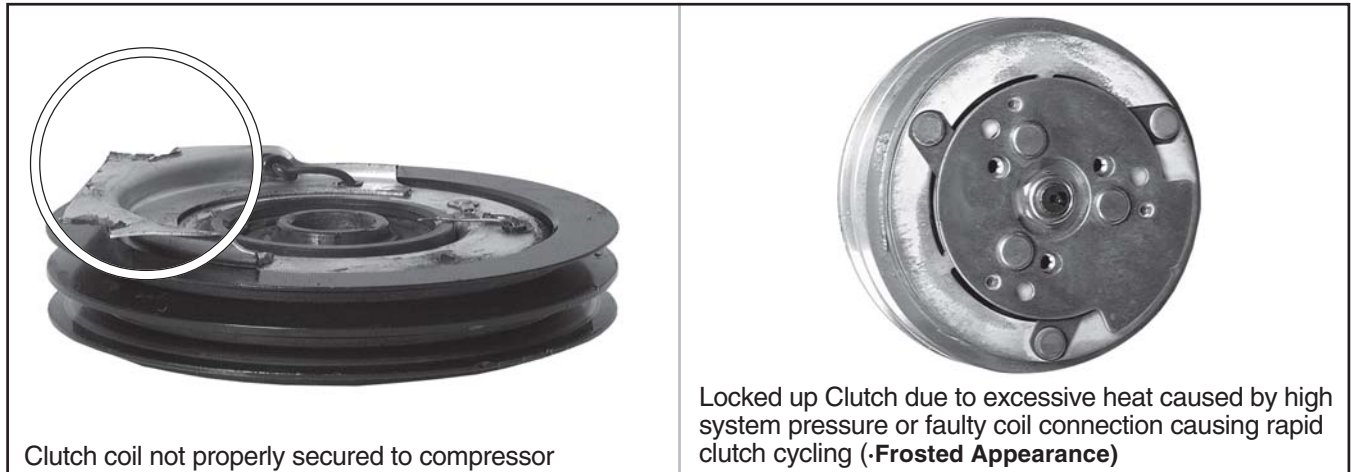
Clutch coil not properly secured to compressor

Locked up Clutch due to excessive heat caused by high system pressure or faulty coil connection causing rapid clutch cycling (**Frosted Appearance**)

- \***Frosted Appearance** - The front hub of the clutch assembly appears to have a frosted color or appearance caused by the rapid cycling of the compressor and clutch assembly. The extreme heat from the slipping will quickly cause the front hub to take on a discolored appearance. At this time, the clutch assembly should be checked as well as the A/C system. To check the clutch assembly: 1. Check for the right amount of voltage for proper engagement. 2. Check and see if the clutch is engaging and disengaging. 3. Check and see if the center rotor is acting as an accessory drive pulley when the clutch is disengaged. 4. Check the gap between the front hub and center rotor. If the clutch checks out to be in operating condition, check the remaining A/C components for failure.

- \***Mounting Bolts** – The mounting bolts used to mount the field coil should be tightened to the OE specs. Failure to properly tighten these bolts can cause the flange holes to elongate. Eventually the field coil will begin to contact the center rotor and cause a clutch failure.

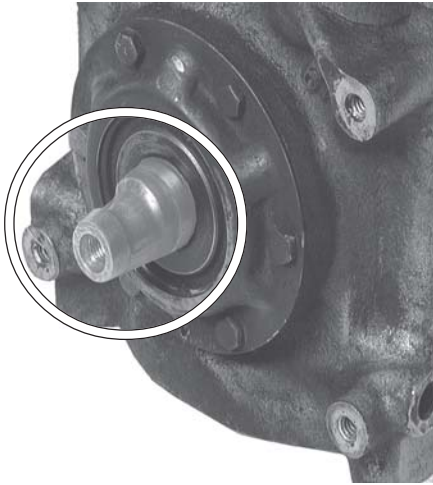
Keyway not properly installed on compressor shaft.

- \***Keyway** – If the shaft key and keyway of the compressor are not lined up correctly during clutch installation, the center rotor will rub up against the field coil. The misalignment will create a rubbing effect on the inner part of the center rotor and the outer housing of the coil.

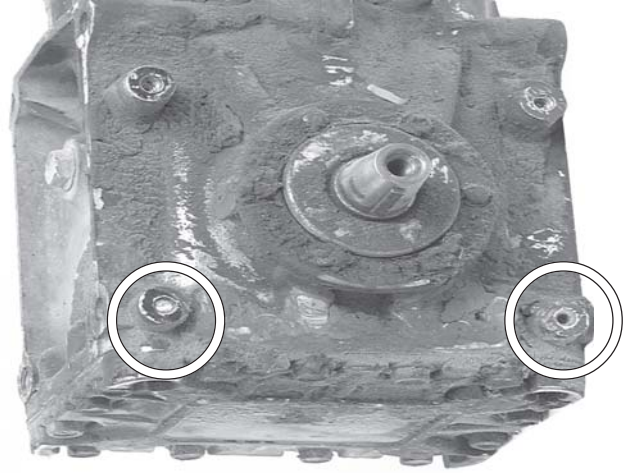
Stripped, broken or damaged clutch mounting threads.

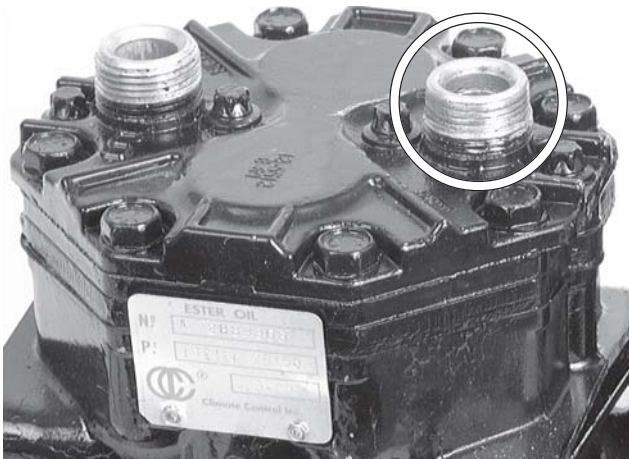
Stripped Fitting due to overtightening service valve.

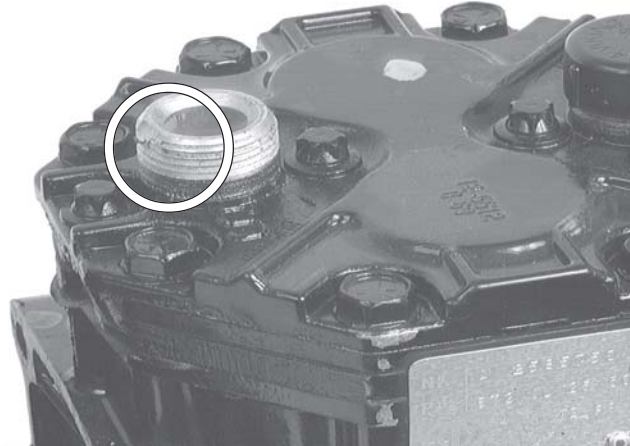
Dropped Compressor shown by the flat dent in threads.

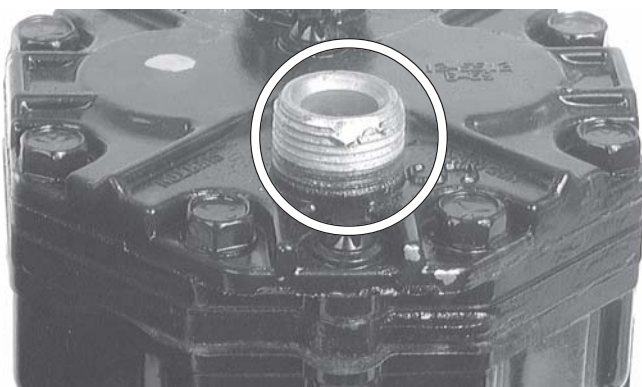
Dropped Compressor shown by flat dent in threads.

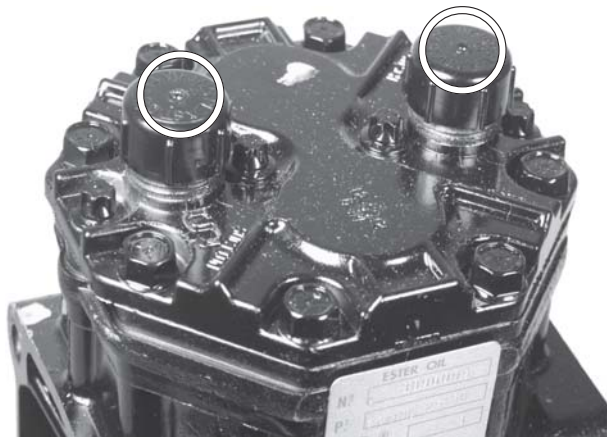
Oil leaking from center of shipping cap. Factory nitrogen charge may cause slight oil leak from center of cap while in box. Check oil level prior to installing compressor.

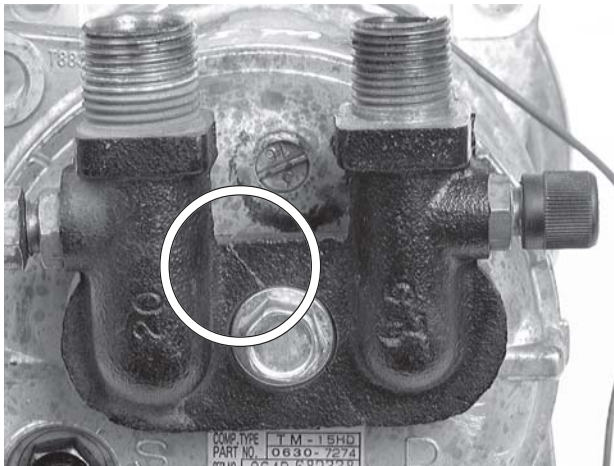
Manifold cracked.

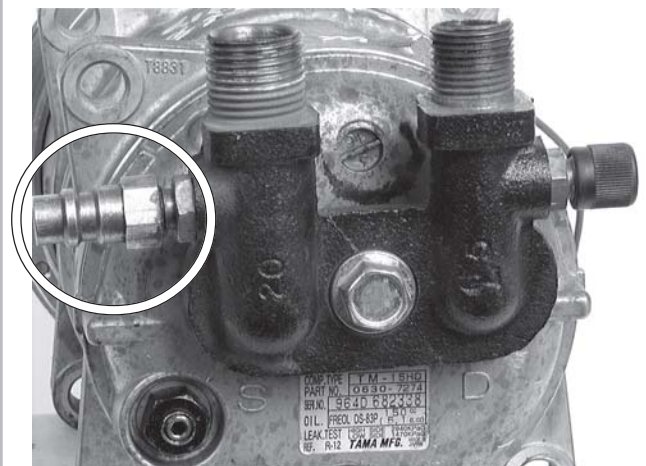
Retro-fitted to 134a, system not flushed.

- **MUST** clean A/C Systems with an approved flush, using an approved flushing method and flush.
- **MUST** replace filter drier or accumulator drier.
- **MUST** replace orifice tube or liquid line that contains orifice tube (if applicable).

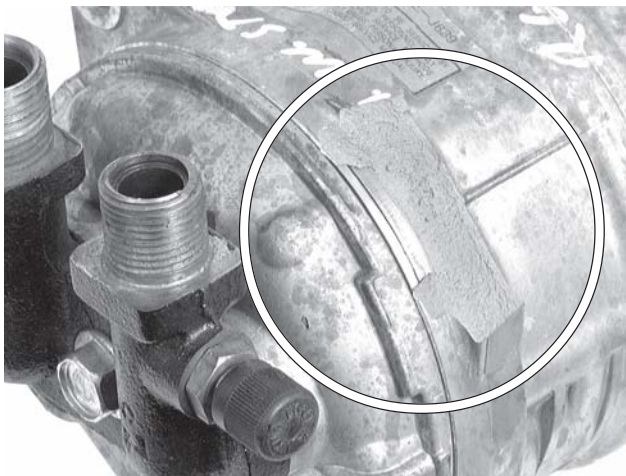
Broken mounting ear.

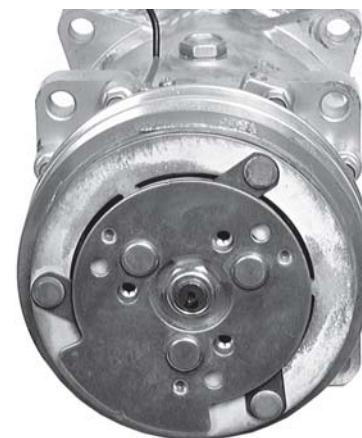
Extreme heat build-up causing clutch failure, due to slipping, lack of lubrication or high system head pressure.

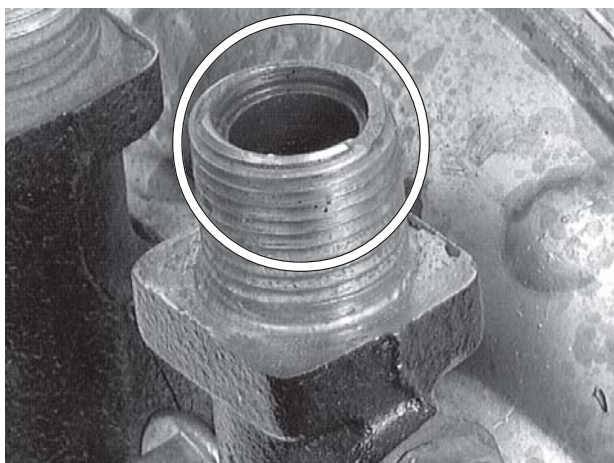
Stripped or damaged hose threads due to over-tightened fittings.
